Subject: WATER IN REAR COMBINATION LIGHT	Bulletin No: 09-005/09
	Last Issued: 1/30/2009

2004-2006 RX-8 vehicles with VINs lower than JM1 FE**** ** 203582 (produced before March 1, 2006)

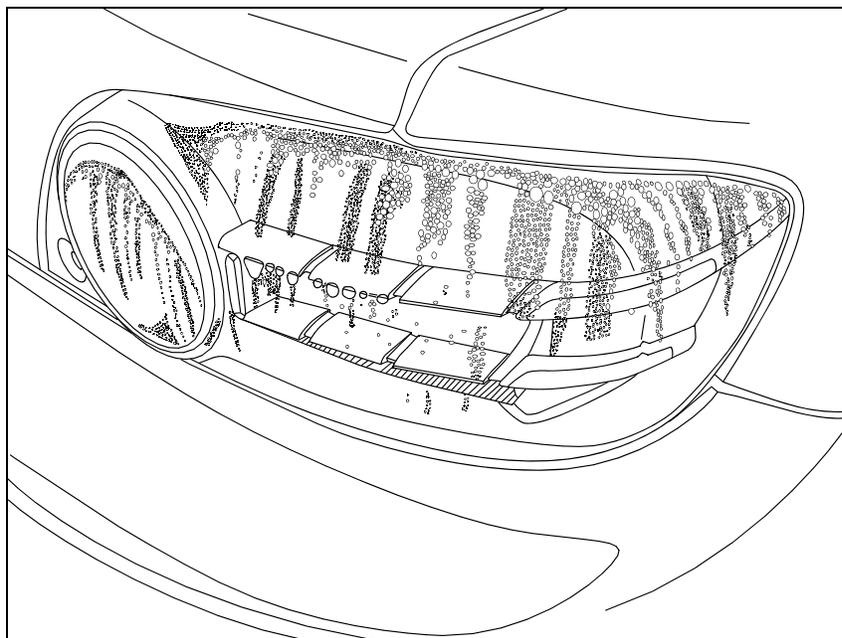
1795a

Some vehicles may experience water entry or excessive condensation inside one or both of the rear combination light assemblies. Water marks may remain on the lens after the water or condensation has evaporated.

Over time, the sealing ability of the combination light gasket decreases. Above the combination light gasket, water can collect and enter the combination light assembly. As a mass production change, a pad has been added to the combination light where the water collects and a thicker gasket has been installed.

Service gaskets and pads are available to replace existing gaskets on combination light assemblies that are not damaged. Customers having this concern should have their vehicle repaired using the following repair procedure.
