M-TIPS

2004 RX-8

Lack of A/C Cooling

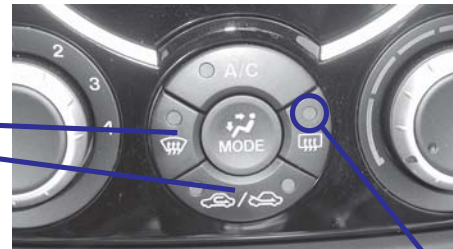
*Press and hold
FRONT DEFROSTER
and AIR INTAKE
CONTROL switches*

*REAR DEFROSTER
indicator light*

1. Verify customer concern.
2. Turn ignition switch to LOCK position.
3. Press and hold FRONT DEFROSTER and AIR INTAKE CONTROL switches simultaneously. Continue holding switches through Steps 4 & 5 below.

4. Turn ignition switch to ACC position for three (3) seconds, then to ON position for three (3) seconds.
5. Watch REAR DEFROSTER indicator light. Reprogramming is successful if REAR DEFROSTER indicator light flashes three (3) times. If not, repeat Steps 2-5.
