© 2010 Mazda Motor of America, Inc.

<b>Subject:</b> HESITATION / IDLE VIBRATION DUE TO CRACKED ENGINE MOUNT	<b>Bulletin No:</b> 01-016/10
	<b>Last Issued:</b> 06/16/2010

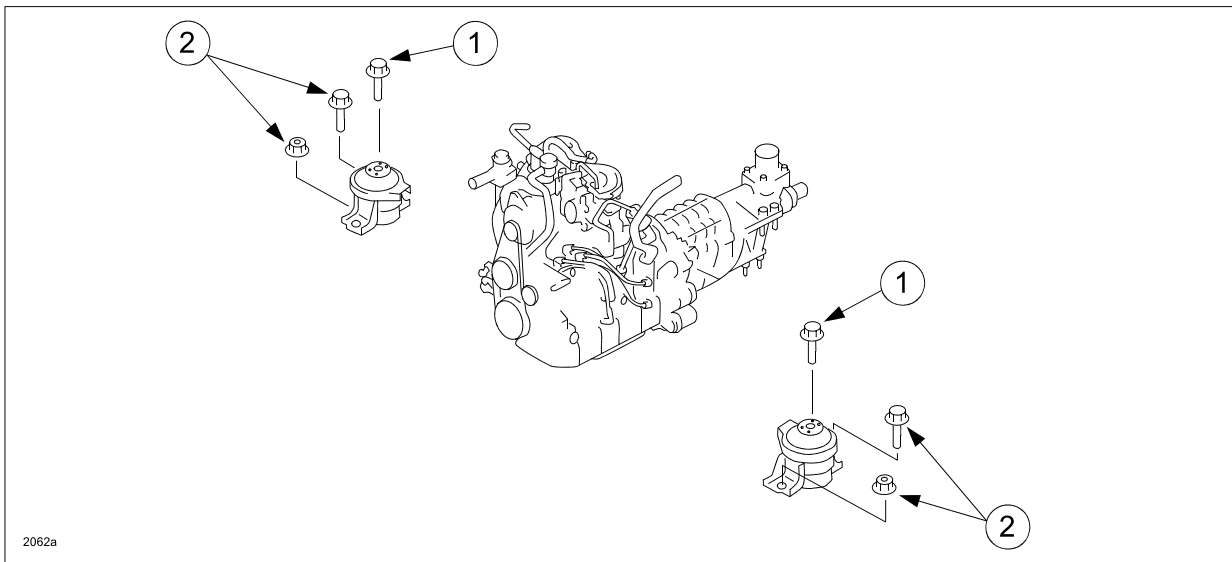
Depending on the driving condition or engine condition, the RH side engine mount rubber may deform. As a result, the RH side engine mount can crack. As a mass production change, the material of the engine mount rubber has been changed.

7. On RH side of engine, remove bolts/nuts in the following order:
  - a. Engine mount bracket-to-engine mount (1).  
Tightening Torque: 37-52 N.m (28-38 ft-lb)
  - b. Engine mount-to-front sub frame (2).  
Tightening Torque: 45-63 N.m (33-46 ft-lb)
