Subject: A/C AIR TEMPERATURE FLUCTUATION AND / OR LACK OF COOLING	Bulletin No: 07-002/04
	Last Issued: 4/22/2004

2004 RX8

VIN: JM1FE17**40 000001-118171 (up to 9/11/03 production).

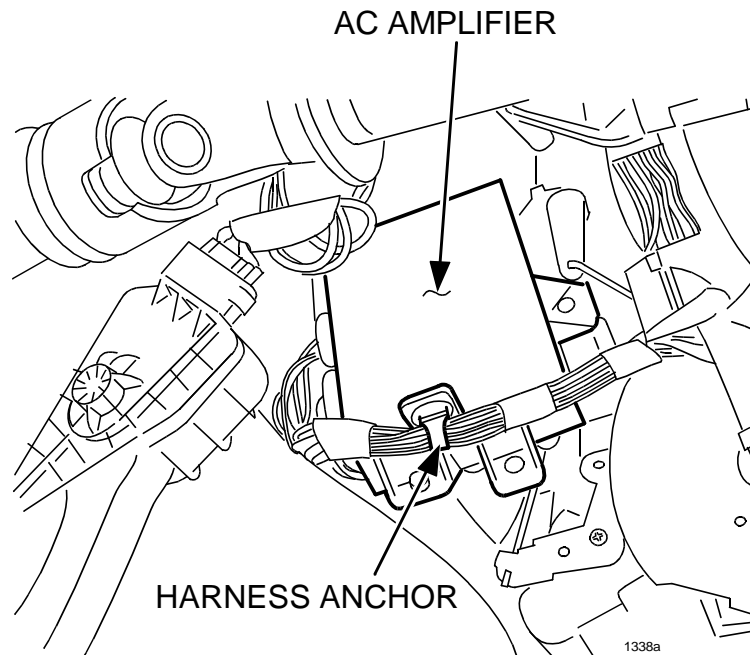
1. Verify customer concern.
2. Ensure ignition switch is off and key is removed from ignition switch.
3. Locate A/C amplifier on left side of blower case near accelerator pedal.

4. Remove 3 screws attaching A/C amplifier to blower case.
5. Remove harness anchor from A/C amplifier.
6. Disconnect harness connectors from A/C amplifier.
7. Replace with new A/C amplifier. To install, reverse removal procedure.
8. Verify that there is no noticeable temperature fluctuation (cool-warm-cool) from the vents.
