<b>Subject:</b> <b>MT - UNUSUAL NOISE WHEN CLUTCH PEDAL IS DEPRESSED</b>	<b>Bulletin No:</b> 05-011/06
	<b>Last Issued:</b> 10/26/2006

2004-2007 RX-8 with VINs lower than JM1 FE\*\*\*\* \*\* 209819 (built prior to September 25, 2006)

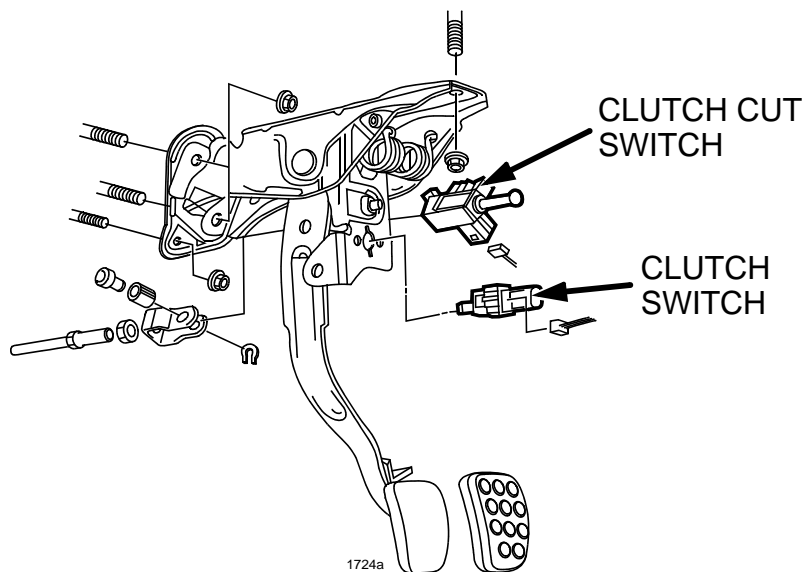
Some vehicles may exhibit a squeaking noise when the clutch pedal is depressed. This noise may be the clutch cut switch.

1. Verify customer concern.
2. Replace clutch cut switch with a revised part.

- Ensure clutch cut switch locks into position when installing.
3. Verify repair.
